# National Highway Traffic Safety Administration

## Update on NHTSA Roof Ejection Research

# FMVSS No. 226 – Ejection Mitigation

2016 SAE Government Industry Meeting

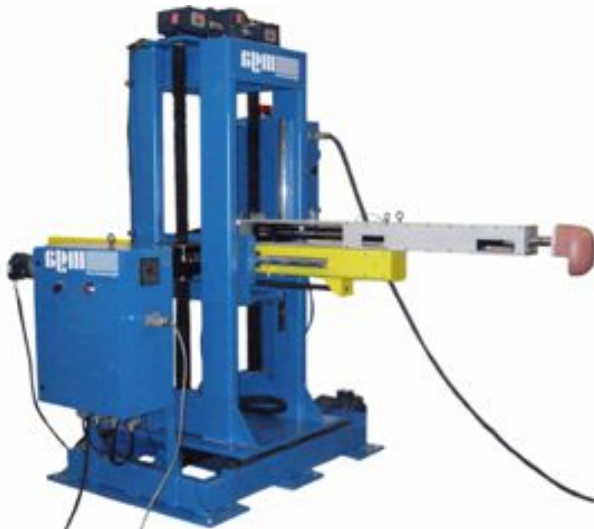
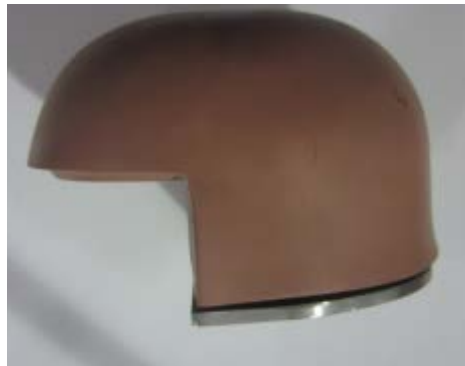
## Guided Impactor

- Featureless Headform
- 40 lbs. (18 kg)
- Displacement from Lin Pot
- Impact Velocity – 10/12.5 mph
- **Used in FMVSS No. 226**

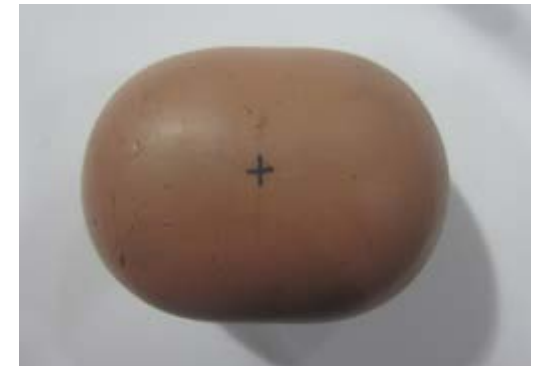
## Free Motion Headform (FMH)

- Featureless Headform
- 10 lbs. (4.7 kg)
- Displacement from Accel
- Impact Velocity – 20/25 mph
- **Equivalent energy to Guided Impactor**

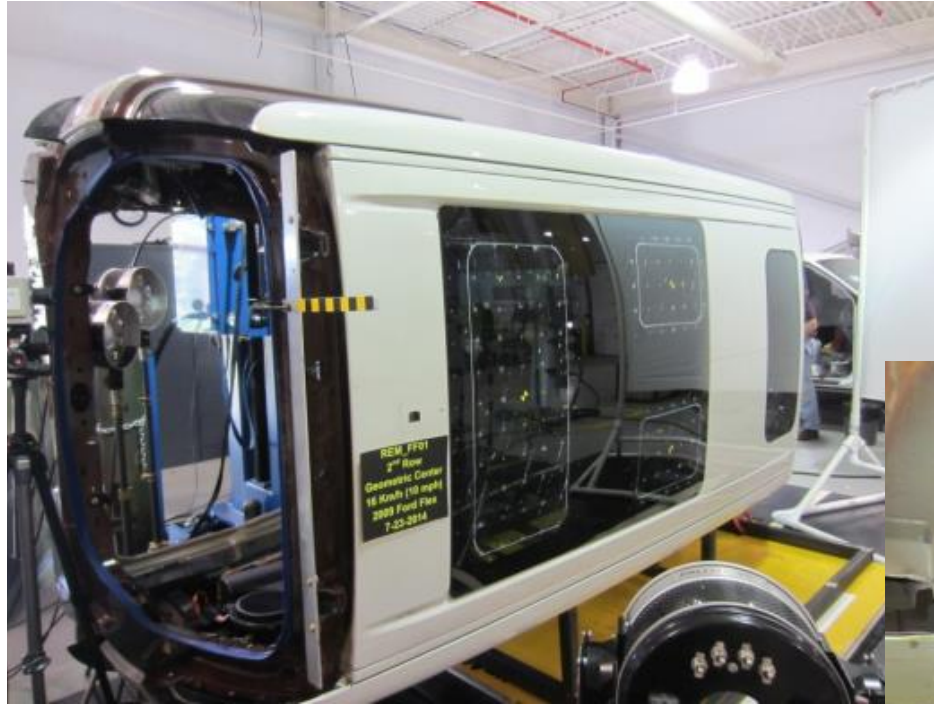
# Test Setup

- Stripped vehicle
- Vehicle rotated 90 degrees
- Cut out floor portion to insert the guided impactor
- Reinforced vehicle for stability and to focus on roof.

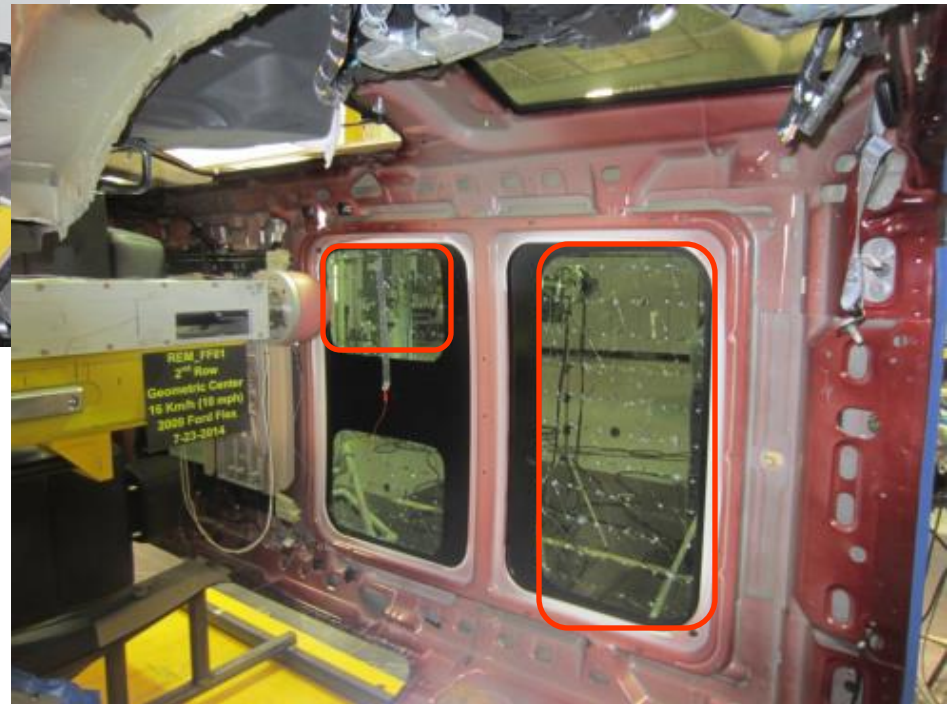
- Daylight opening definition consistent with FMVSS No. 226 procedure
- Impact locations: geometric center and corners.

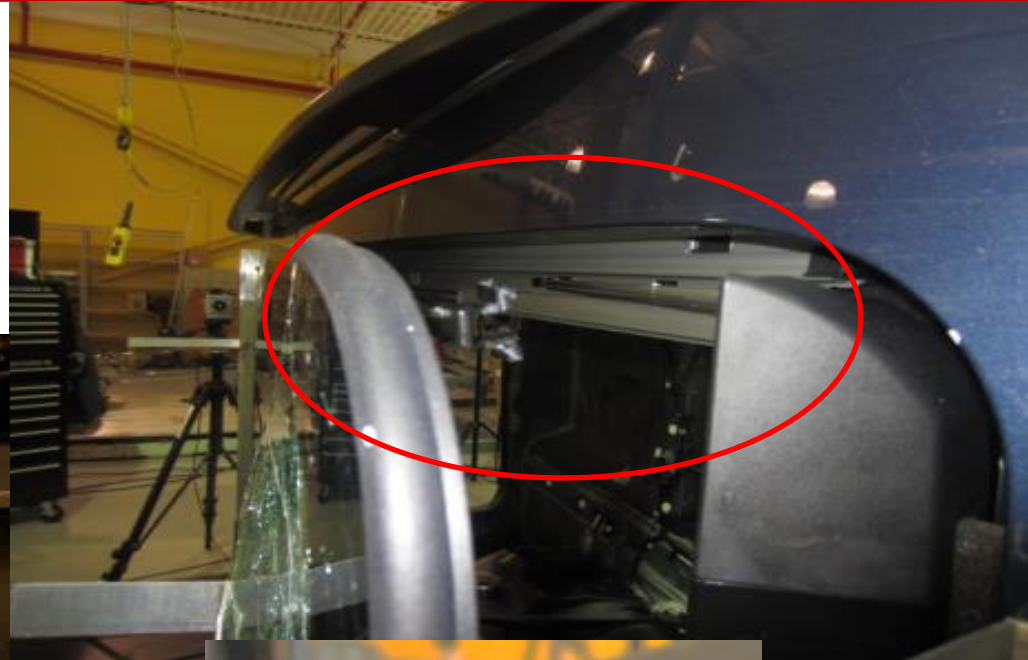
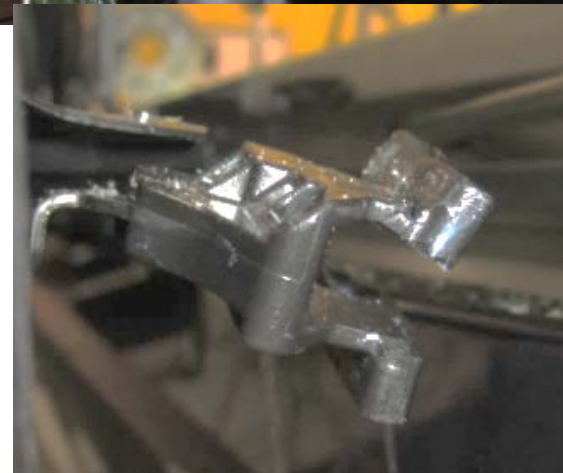
# 2014 Subaru Forester (Movable)

- Test: REM SF05
  - Upper forward corner
  - Impact directed outward
  - 10 mph
  - 222 mm excursion

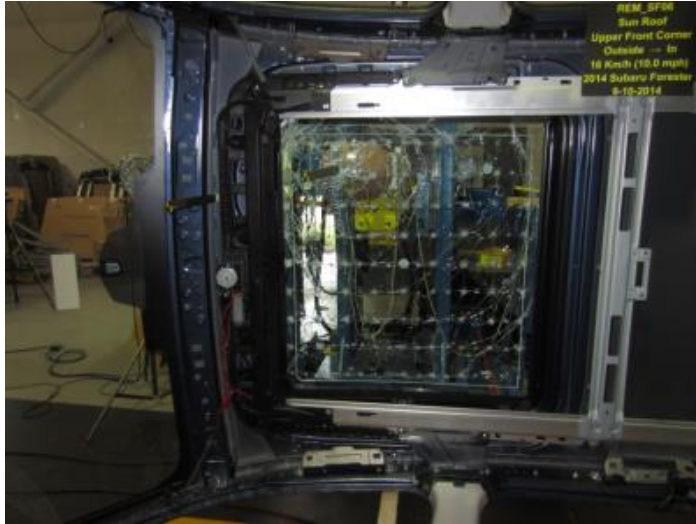
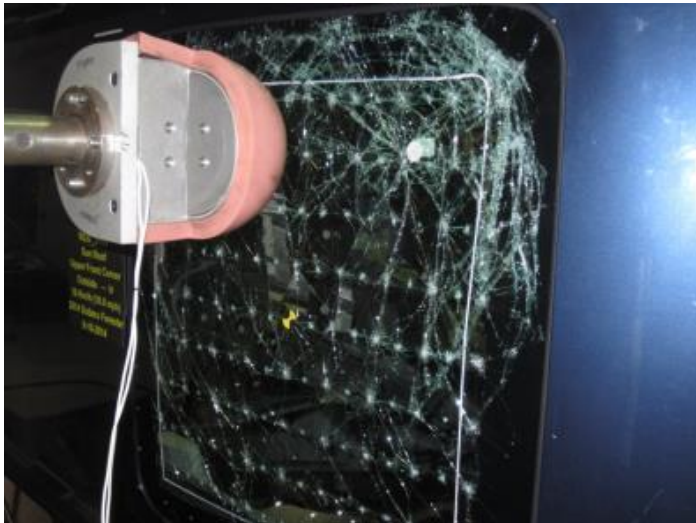
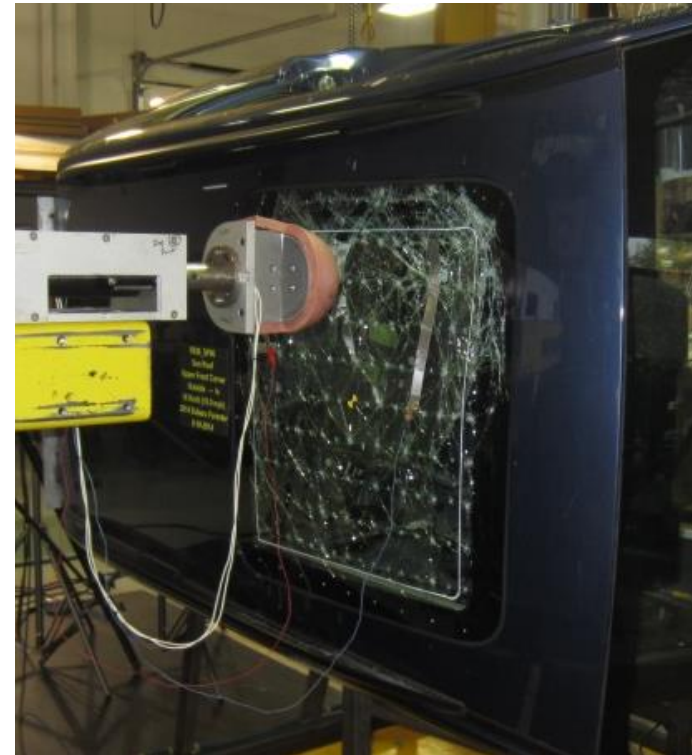
# 2014 Subaru Forester (Movable)

- Test: REM SF06
  - Upper forward corner
  - Impact directed inward
  - 10.1 mph
  - 112 mm excursion

100 mm less  
than outward  
impact!

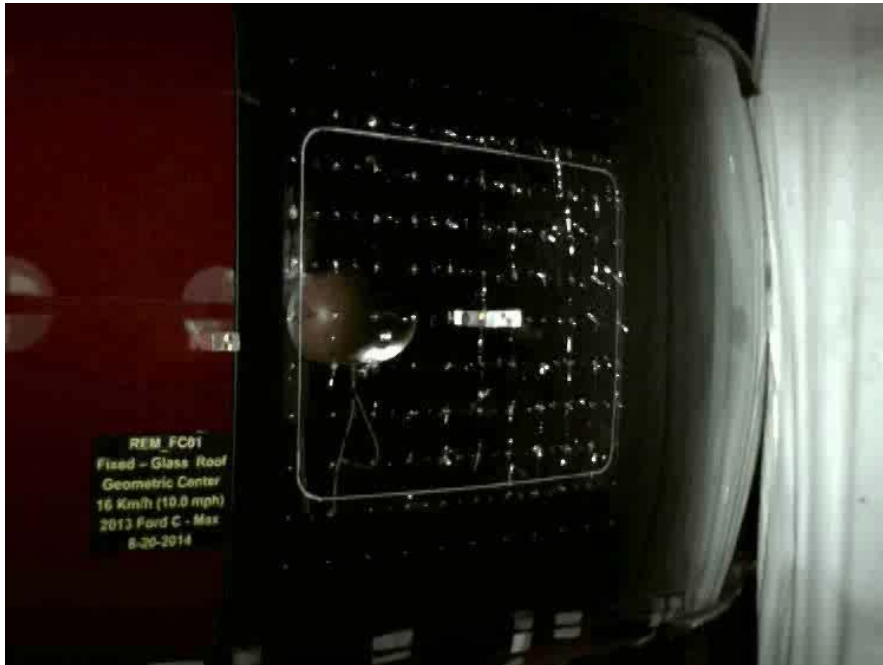
Video:  
Geometric Center – 10 mph

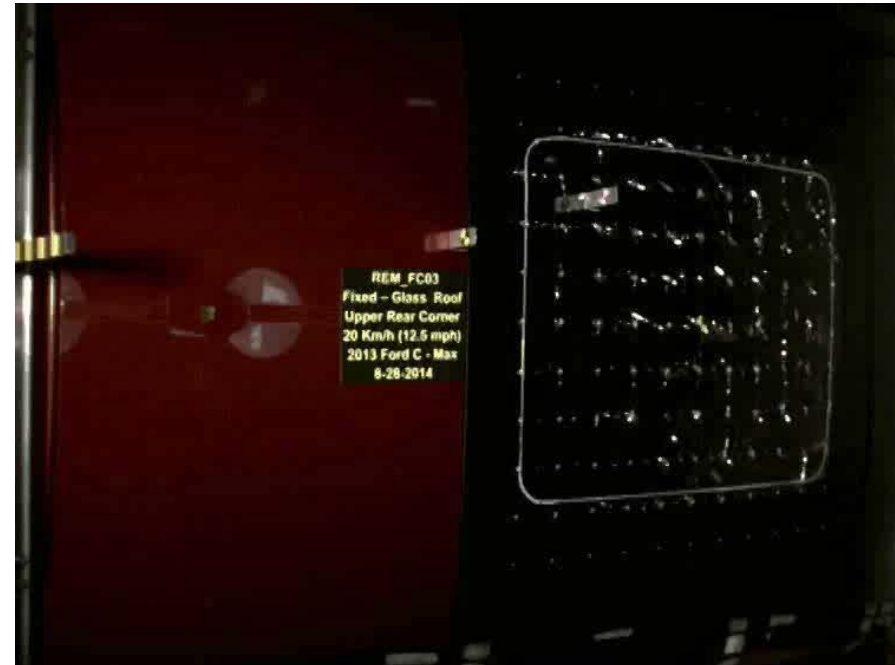
Video:  
Upper Rear Corner – 12.5 mph

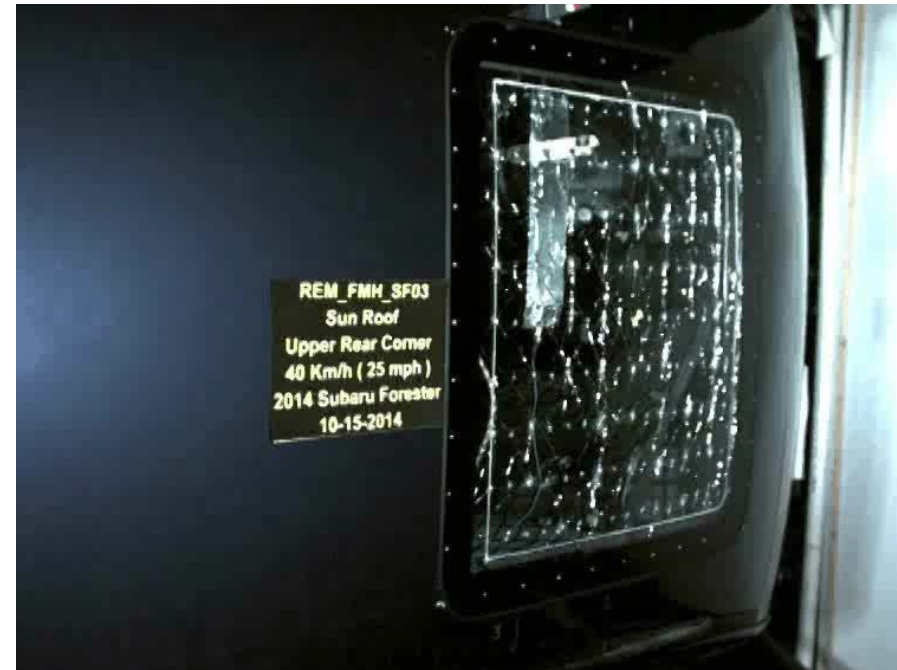
Video: FMH (25 mph)

2014 Subaru Forester (Movable) – Upper Rear Corner
